Supplemental Service Manual

906-2150-002 Rev. C, TEXT ONLY

***Centurion** Vision System Supplemental Service Manual**

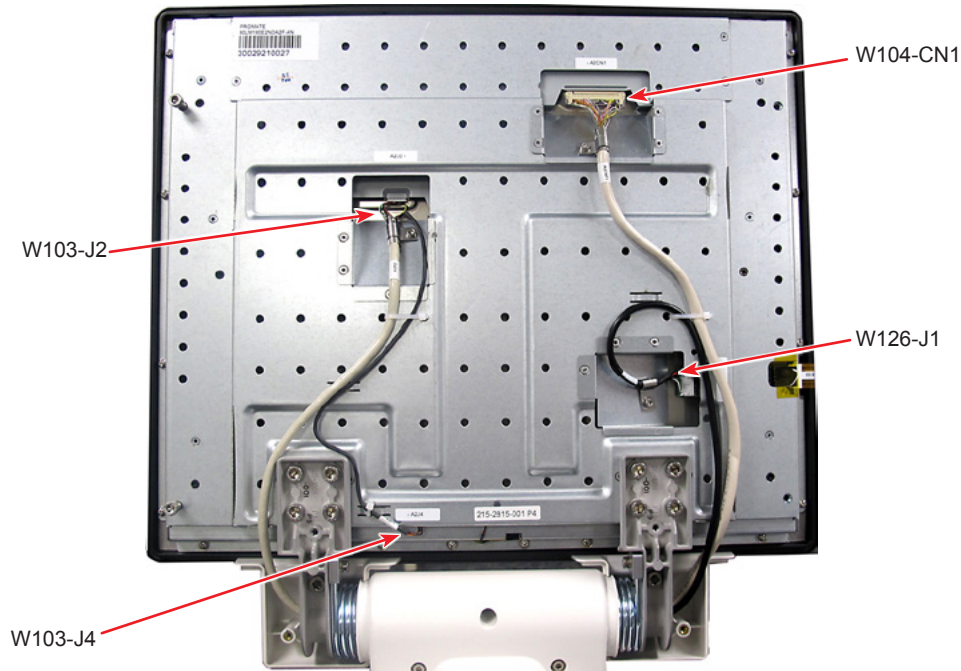
Figure 3-87 Display with Covers Removed

- 66.1 Remove the following items per Table 3-1:
 - Fluidics Module and Fluidics Controller Assembly
 - Remove Upper Left Panel
 - Remove Display Wrap Handle and Display Bucket
 - Remove Rear and Front Knuckle Covers
- 66.2 Cut all tie wraps securing cable W126.
- 66.3 Remove a 2.5 mm hex screw securing W126 cable clamp to Display Assembly.

- 68.1 Remove USB Touch Screen Interface Cable Assembly W126 per step [66](#).
- 68.2 Remove 2.5 mm hex screw securing W104 cable clamp to Display Assembly.
- 68.3 Carefully disconnect CNP1 by squeezing latch on each side to release (see [Figure 3-87](#)).
- 68.4 Position CNP1 connector sideways at feed-through channel and pull cable W104 from the other end. **Notes: Do this slowly and carefully to avoid damage on connector.**
- 68.5 Disconnect the other end of W104 cable from the Host Module at connector J2, and remove W104 Cable Assembly.
- 68.6 Install replacement W104 Cable Assembly.
- 68.7 Install USB Touch Screen Interface Cable Assembly.
- 68.8 Connect W104 cable connectors to the Display Assembly and Host Module.
- 68.9 Secure cable assembly with tie wraps as required.

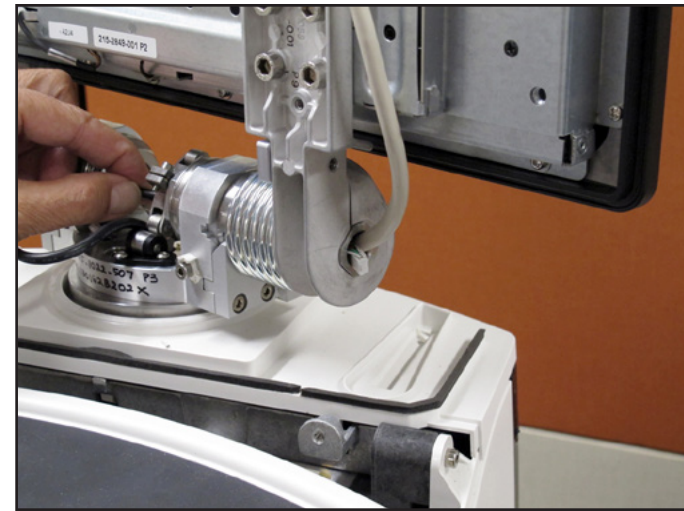
Figure 3-88 Cable Feed-Through Channel

- 66.4 Carefully disconnect P1 from Display Assembly.
- 66.5 Position P1 connector sideways at the knuckle feed-through channel as shown in [Figure 3-88](#).

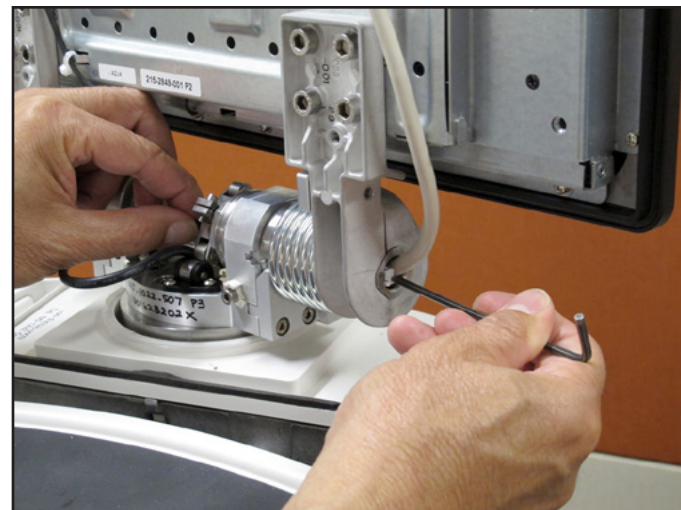
Figure 3-89 Removing Cable Assembly W126

- 66.6 Use a hex wrench to push connector P1 into the feed-through channel and pull cable W126 from the other end simultaneously as shown in [Figure 3-89](#). **Note: Do this slowly and carefully to avoid any damage to connector P1.**

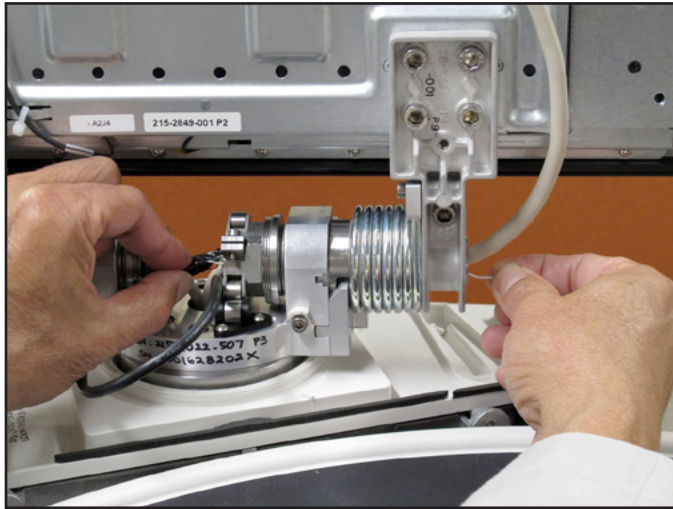
Figure 3-90 Installing the Replacement W126 Cable Assembly

- 66.8 Attach (twist) a spare piece of wire at connector P1 and secure with a piece of electrical tape wrapped around the wire (see [Figure 3-90](#)).

- 66.9 Feed the wire through the knuckle feed-through channel until it extends out the other side.
- 66.10 Position connector P1 sideways in the channel then start simultaneously pulling the wire and pushing the cable through.
- 66.11 Connect W126 cable connectors to the Display Assembly and Host Module.
- 66.12 Secure cable assembly with tie wraps as required.

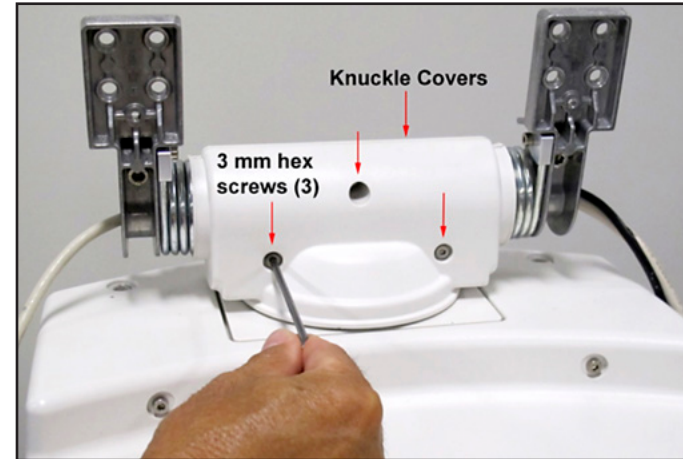
Figure 3-91 Knuckle Covers Removal

- 69.1 Remove Display Assembly per step [37](#).
- 69.2 Remove three 3 mm hex screws securing Knuckle Covers to Display Hinge and remove from console (see [Figure 3-91](#)).

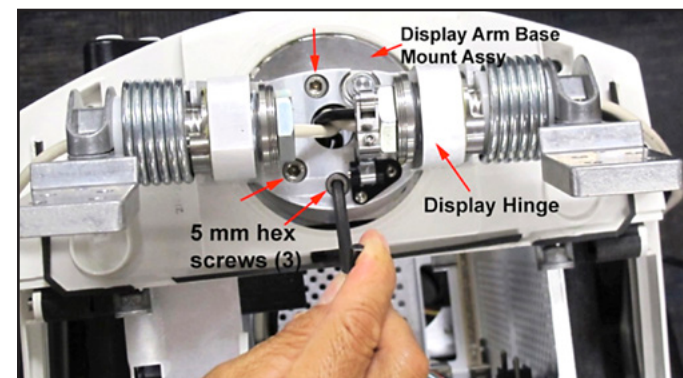
Figure 3-92 Display Hinge Removal

- 69.3 Remove Work Surface (step [8](#)) and Display Insert Assembly (step [9](#)).
- 69.4 Remove three 5 mm hex screws securing Display Hinge onto Display Arm Base Mount Assembly (see [Figure 3-92](#)).

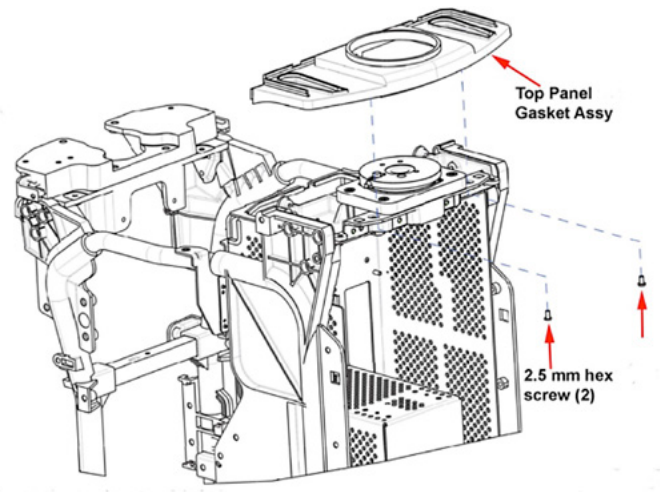
Figure 3-93 Top Panel Gasket Assembly

- 69.5 Carefully remove Display Cable Assemblies from Display Hinge and remove Display Hinge from console (refer to Display Cable Assemblies removal in steps [66](#), [67](#), and [68](#) for detail).
- 69.6 Remove Front Vent (step [3](#)), Upper Front (step [4](#)) and Lower Front (step [5](#)) Panels.
- 69.7 Remove Ultrasonics (U/S) PCB Assembly (step [19](#)), Fluidics Module and Fluidics Controller Assembly (step [18](#)).
- 69.8 Remove two 2.5 mm hex screws securing Top Panel Gasket Assembly and remove from console (see [Figure 3-93](#)).

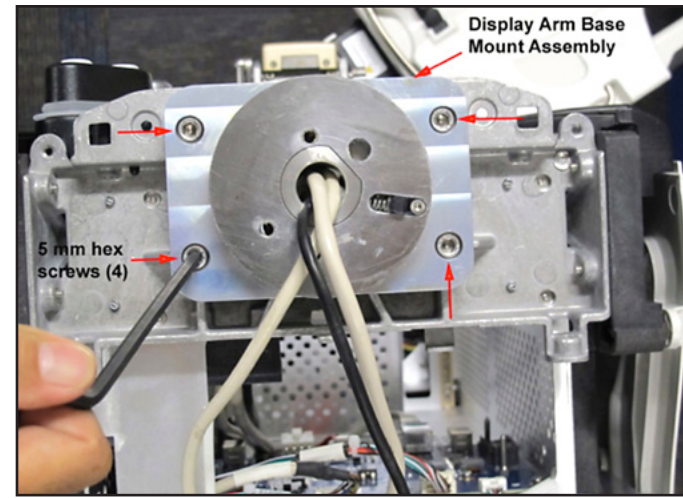
Figure 3-94 Display Arm Mount Assembly Removal

- 69.9 Remove four 5 mm screws securing Display Arm Base Mount Assembly (see [Figure 3-94](#)).
- 69.10 Carefully remove Display Cable Assemblies from Display Arm Base Mount Assembly and remove Display Arm Base Mount Assembly.

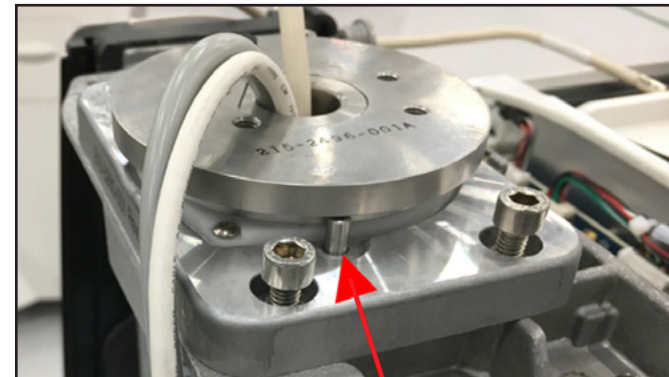
Figure 3-95 Replacement of Display Arm Mount Assembly

- 69.11 When installing Display Arm Base Mount Assembly, ensure pin is on the correct side as shown in [Figure 3-95](#).

Install Display Arm Mount
Assembly with pin on this side

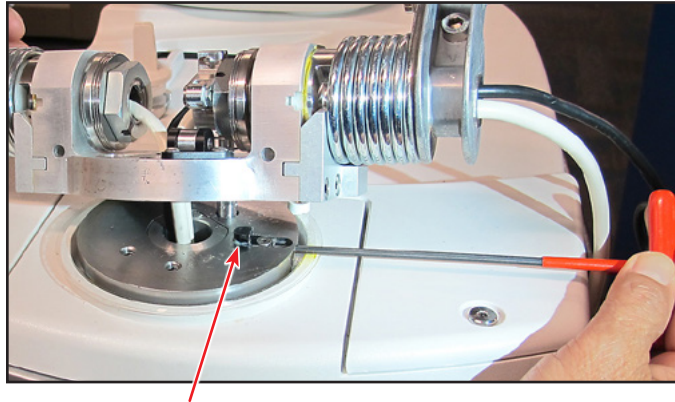
Figure 3-96 Push and Hold The Latch of Display Arm Mount Assembly

- 69.12 When installing the Display Hinge, use a small Allen wrench to push the latch of Display Arm Mount Assembly until it stops ([Figure 3-96](#)), and place Display Hinge onto Display Arm Mount Assembly ([Figure 3-97](#)).

Latch of Display Arm
Mount Assembly

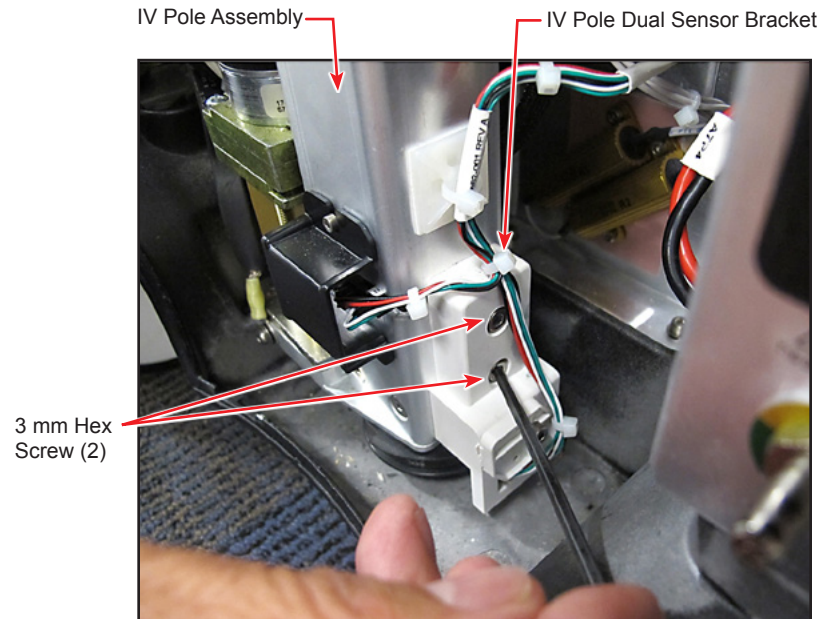
Figure 3-98 IV Pole Dual Sensor Bracket Removal

- 70.1 Remove Upper (per step [1](#)) and Lower Rear Panels (per step [2](#)).
- 70.2 Remove two 3 mm hex screws securing IV Pole Dual Sensor Bracket to IV Pole Base (see [Figure 3-98](#)) and remove from IV Pole Assembly.

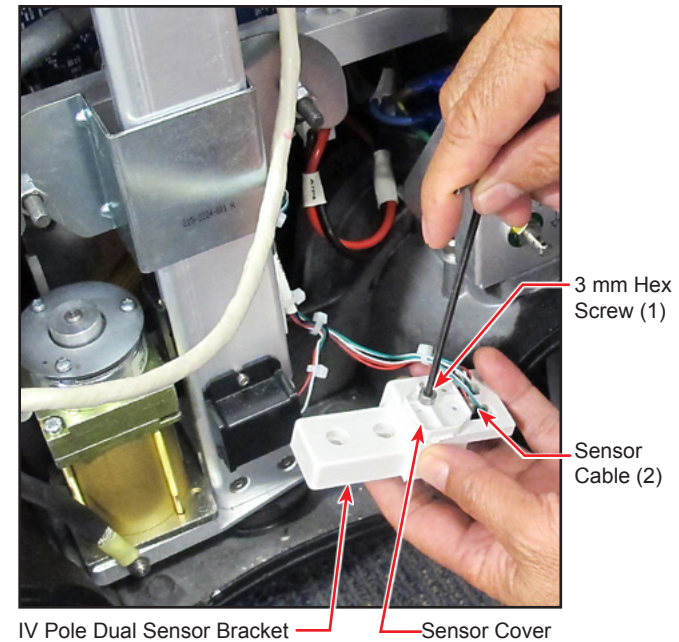
- 70.4 Remove one 3 mm hex screw securing Sensor Cover onto Dual Sensor Bracket (see [Figure 3-99](#)), and remove Sensor Cover from IV Pole Dual Sensor Bracket.

Figure 3-99 Sensor Cover Removal

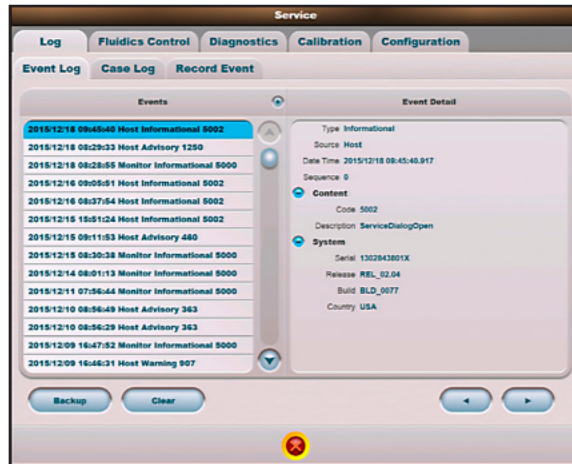
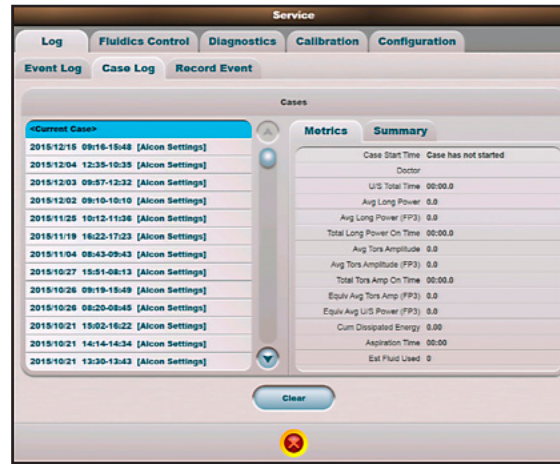
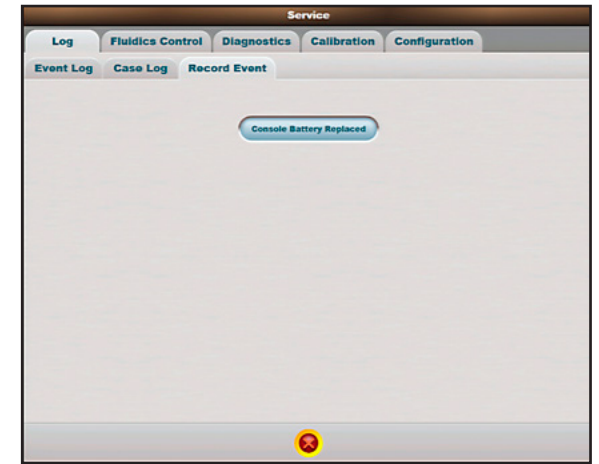
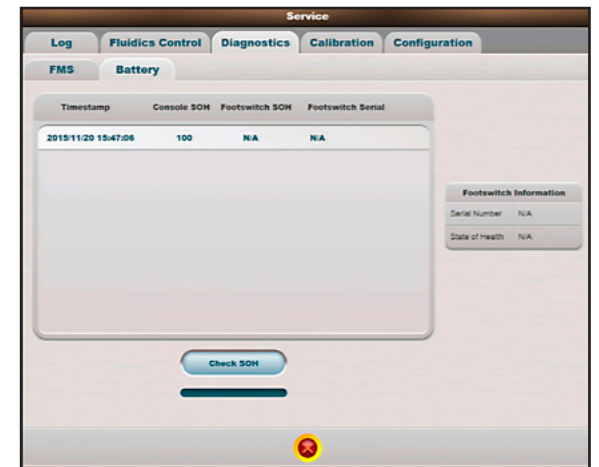
Figure 4-2 Service Mode Screens for Software Version 2.04

1.1.3 When the About screen is displayed, alternately tap once on each side of the word "About" in the title bar of the screen. The Service screen will be displayed as shown in [Figure 4-1](#) or [Figure 4-2](#). The Event Log tab is the default view.

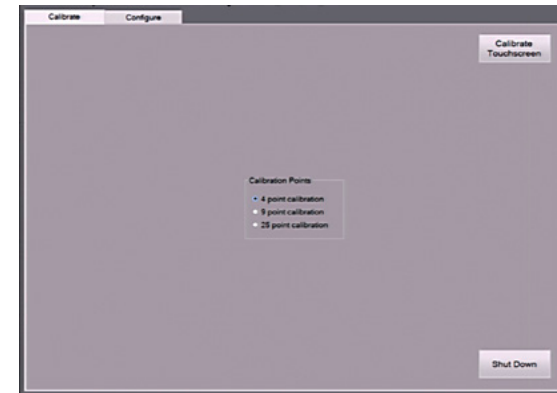
2.1.5 Ensure Calibrate tab is highlighted in upper left corner. (see [Figure 4-4](#)).

Figure 4-4 The Configuration Installer Screen - Calibrate Tab

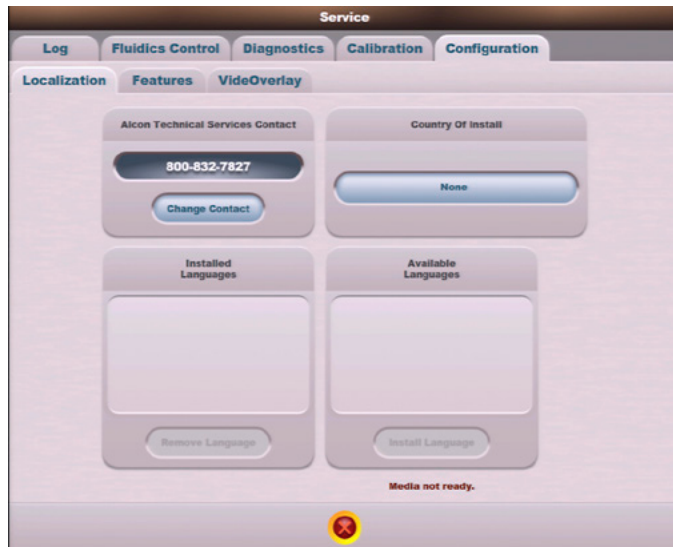
- 2.3.20 From Service screen – Configuration – Localization, enter Country of Install (see [Figure 4-13](#)).
- 2.3.21 If any advisories, warnings, or fault messages are displayed, troubleshoot as necessary.

Figure 4-13 Localization Tab - Country of Install

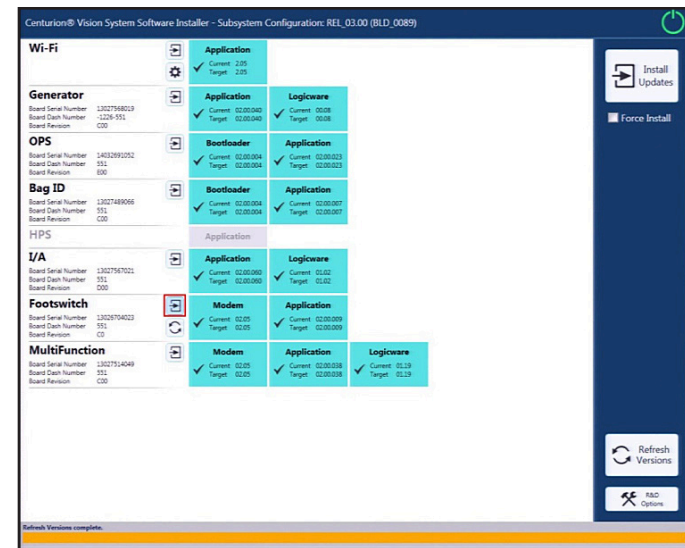
2.4.10 Select the *Subsystem Install Updates Button* (shown in [Figure 4-17](#)).

Figure 4-17 Subsystem Install Updates Button

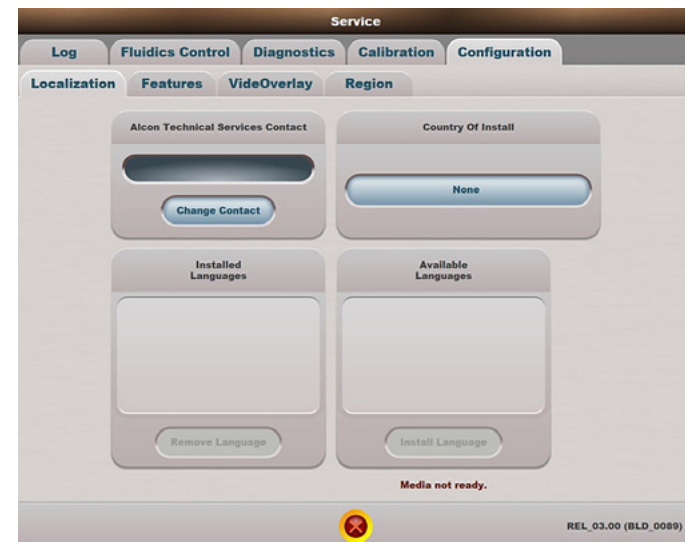
Figure 4-18 Service - Configuration - Localization Screen

- 2.4.23 System Configuration
 - 2.4.23.1 Navigate to Service mode, and then select the Configuration and Localization tabs.
 - 2.4.23.2 Set the Country of Install (see [Figure 4-18](#)).

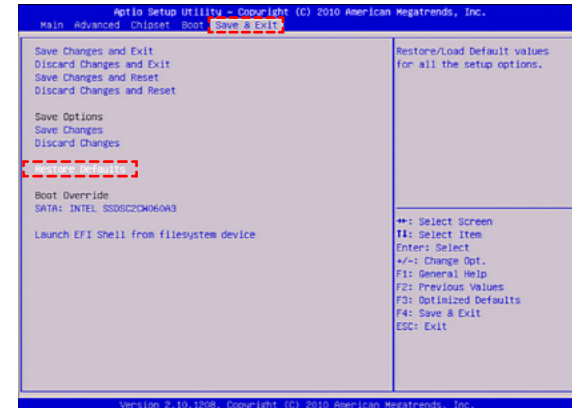
Figure 4-19 BIOS Screen

- 3.1 If necessary, remove USB service media from Service Panel USB port.
- 3.2 Attach a keyboard to a Rear-Panel I/O USB slot.
- 3.3 Apply console power. Repeatedly press and release the DEL button until prompted to enter a BIOS password.
- 3.4 Enter BIOS password:
 - 3.4.1 For 2.01 and 2.03 software versions: Enter the BIOS password/access code as CON\$0LE (all CAPs; 0 = numeral 0, not a letter O).
 - 3.4.2 For 2.04 and 3.0X software versions: Enter the BIOS password/access code as CON\$0LE#2 (all CAPs; 0 = numeral 0, not a letter O).
- 3.5 In the BIOS Setup utility, use the arrow keys to navigate to "Save & Exit," select "Restore Defaults" and press Enter (see [Figure 4-19](#)).

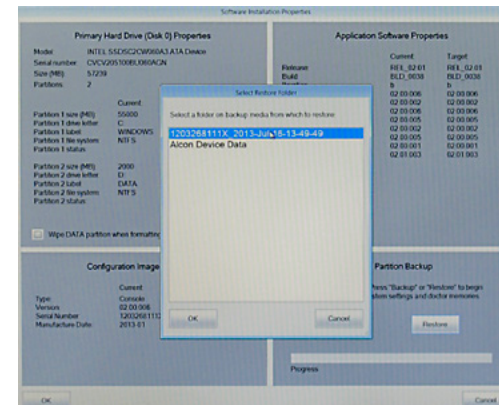
Figure 4-21 Selecting the Restore File

- 4.2.1 If necessary, perform steps [4.1.1](#) through [4.1.3](#).
- 4.2.2 Plug the USB media containing the data into one of the rear I/O USB ports.
- 4.2.3 In the DATA Partition Backup section (see [Figure 4-20](#)), click Restore.
- 4.2.4 Select the appropriate data file and click OK (see [Figure 4-21](#)).

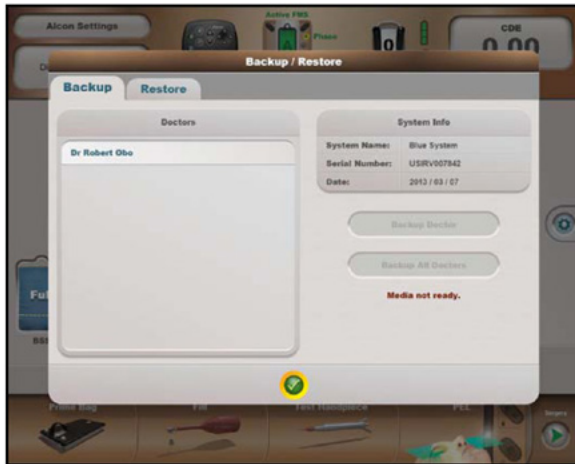
- 5.1.1 Plug a USB media into one of the rear I/O USB ports.
- 5.1.2 Select Backup/Restore from the Custom Menu. The Backup tab is the default as shown in [Figure 4-22](#).
- 5.1.3 To backup an individual doctor: select *Doctor*, then press *Backup Doctor*.
- 5.1.4 To backup all Doctors: press *Backup All Doctors*.

Figure 4-22 Backup/Restore Dialog Screen - Backup Tab

- 5.2.1 Plug the USB media containing the Doctors Settings into one of the rear I/O USB ports.
- 5.2.2 Select Backup/Restore from the Custom Menu. The Backup tab is the default as shown in [Figure 4-22](#).
- 5.2.3 Press the Restore Tab (see [Figure 4-23](#)).

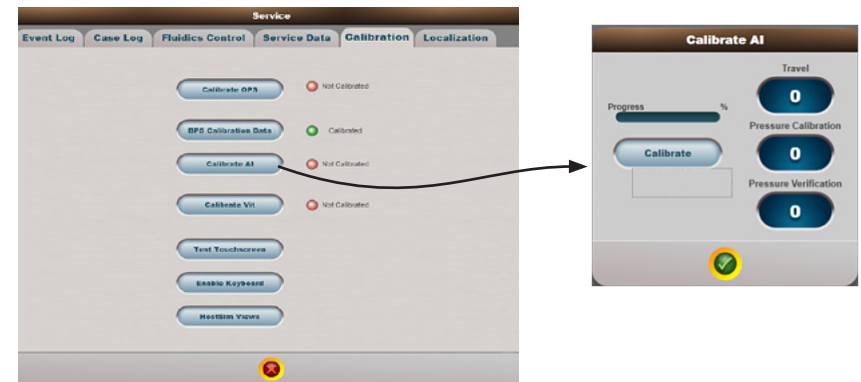
- 7.1 Go to the Service Screens.
 - 7.1.1 From the surgical setup screen, press the Menu icon, then About.
 - 7.1.2 To access the hidden Service menu, press to the right and then to the left of the word “About” at the top of the window.
- 7.2 Next press Calibration tab, and press “Calibrate AI” button (see [Figure 4-24](#)).

Figure 4-24 Service Calibration Screens for Calibrating Active Irrigation

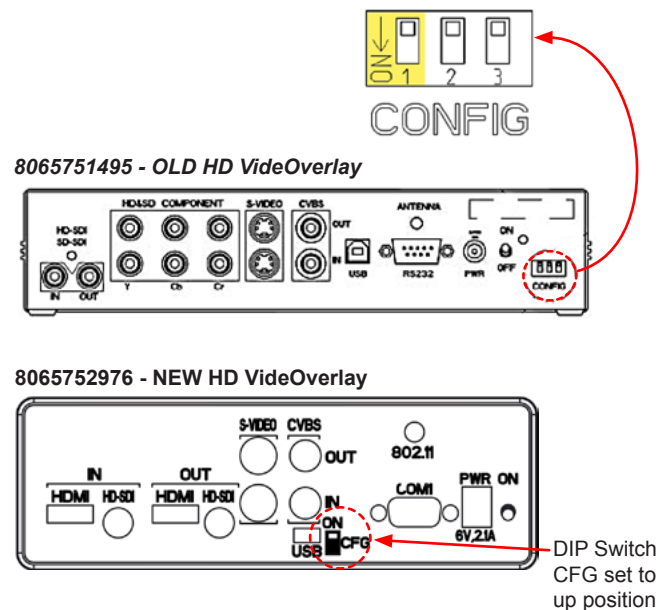
- 8.1 Install Wi-Fi Device Configuration Utility (WDCU) on laptop:
 - 8.1.1 On the *Centurion** Service Media USB Drive with directory labeled VideoOverlayConfigurationUtility, locate file WDCU.exe located in subdirectory WiFiDeviceConfigurationUtility.
 - 8.1.2 Copy file WDCU.exe onto laptop.
- 8.2 Configure VideoOverlay (VO) with WDCU:
 - 8.2.1 On the HD VideoOverlay Rear Panel, set DIP Switch 1 to the "ON" position (see [Figure 4-25](#)).

Figure 4-25 VideoOverlay DIP Switch Setting

- 9.1 Turn the *Centurion** system on.
- 9.2 DIP Switch Settings:
 - 9.2.1 For old HD VideoOverlay, set DIP Switch 1 to the "ON" position (see [Figure 4-25](#)).
 - 9.2.2 For new HD VideoOverlay, set DIP Switch CFG to the up position (see [Figure 4-25](#)).
- 9.3 Connect the 50 foot serial cable (023-082, shipped with HD VideoOverlay box) from the *Centurion** Rear Panel serial port (female) to the VideoOverlay box serial port (male).

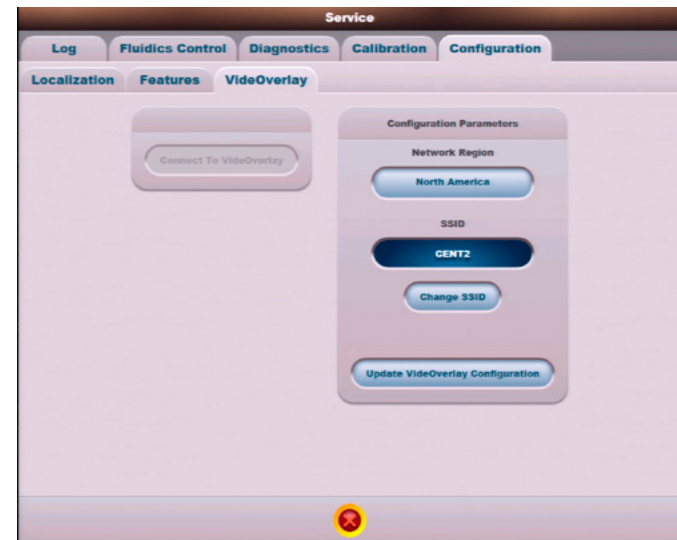
Figure 4-26 VideoOverlay Configuration Screen

- 9.4 Turn the VideoOverlay on.
- 9.5 On the *Centurion** system, enter service mode, select Configuration tab, and select VideoOverlay tab (see [Figure 4-26](#)).

- 9.7.2 For new HD VideoOverlay, the displayed message will go away automatically within three seconds and no action is needed.
- 9.8 The Configuration Parameter should be active and ready for configuration as shown in [Figure 4-26](#).

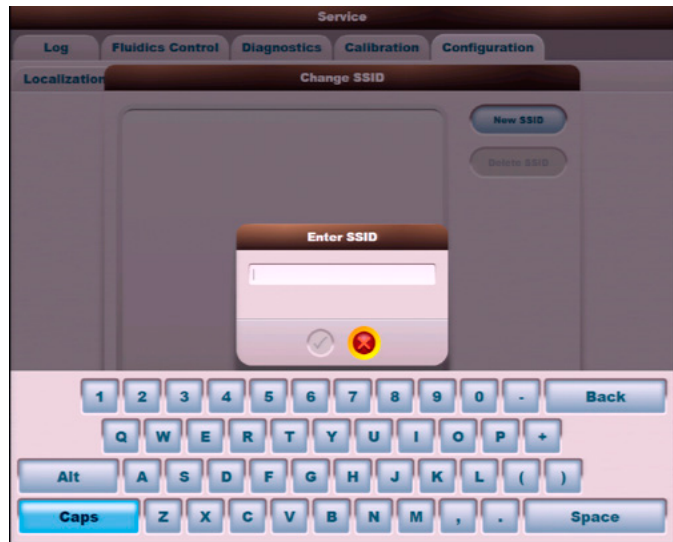
Figure 4-27 VideOverlay SSID Entry Screen

- 9.10 Configure SSID by select "Change SSID" and then "New SSID" (see [Figure 4-27](#)). Enter a valid SSID and select the green check icon.
- 9.11 Select green check mark to save SSID.
- 9.12 Select "Update VideoOverlay Configuration." When complete, close the Service window.
- 9.13 Turn off VideoOverlay box and remove serial cable.
- 9.14 Turn on VideoOverlay box as follows:
 - 9.14.1 For old HD VideoOverlay, turn on the VideoOverlay.
 - 9.14.2 For new HD VideoOverlay, set DIP Switch CFG to the down position and turn on the VideoOverlay.
- 9.15 On *Centurion** wireless screen, enter the same SSID and Network Region. Ensure WiFi Network is set to On. Select green check mark icon to save.
- 9.16 Test to ensure wireless VideoOverlay is functioning properly through the wireless network.

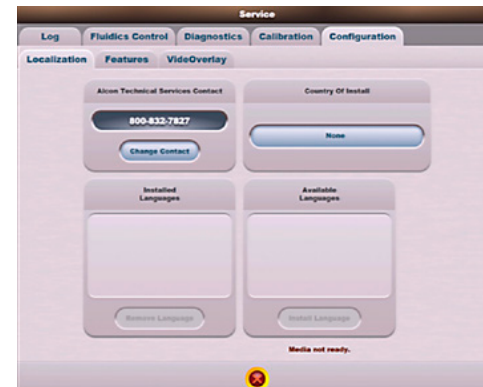
Figure 4-29 Localization Tab for 2.04 Software Version

- 10.3.2 For 2.04 software, select Configuration tab, then Localization tab.

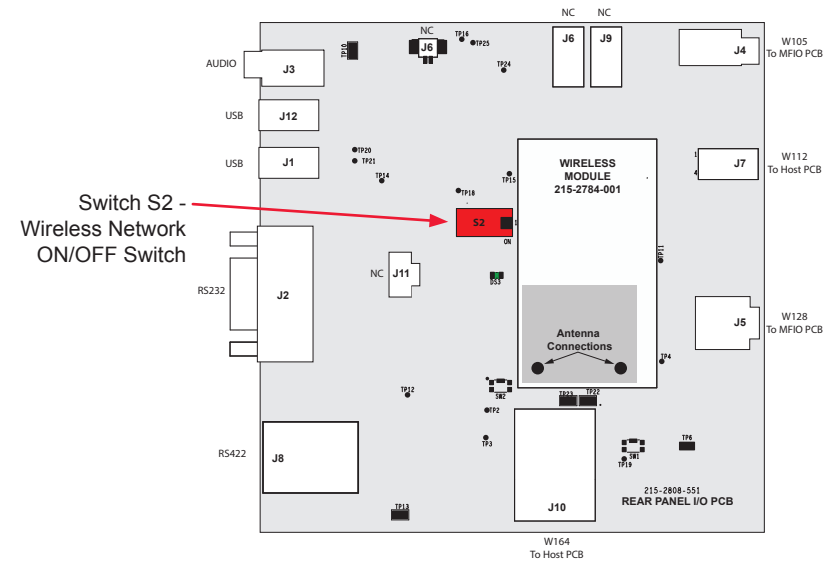
Figure 4-30 Wireless Network ON/OFF Switch on Rear Panel I/O-Wireless Module Assembly

- 11.2.1 Remove Upper and Lower Rear Panels (see Section 3 for detailed instructions).
- 11.2.2 On Rear Panel I/O-Wireless Module Assembly, move switch S2 into the off position to disable network wireless activity (see [Figure 4-30](#) for switch location).

NOTE: LED DS3 illuminates green when Wi-Fi is on, and is not illuminated when Wi-Fi is off.

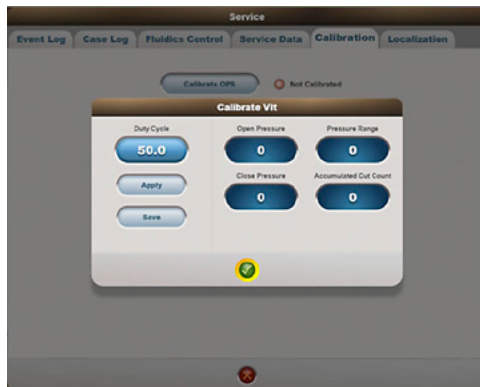
Figure 4-31 The Calibrate Vit Screen in Service Mode

- 12.1.1 After console power up, insert cassette and prime system.
- 12.1.2 From the Setup screen, press the Custom Menu (Gear) button on the touchscreen then select "About".
- 12.1.3 Alternately tap on each side of the word "About" to enter the Service Screen.
- 12.1.4 Select "Calibration" tab.
- 12.1.5 Press "Calibrate Vit" button to bring up "Calibrate Vit" Screen (see [Figure 4-31](#)).

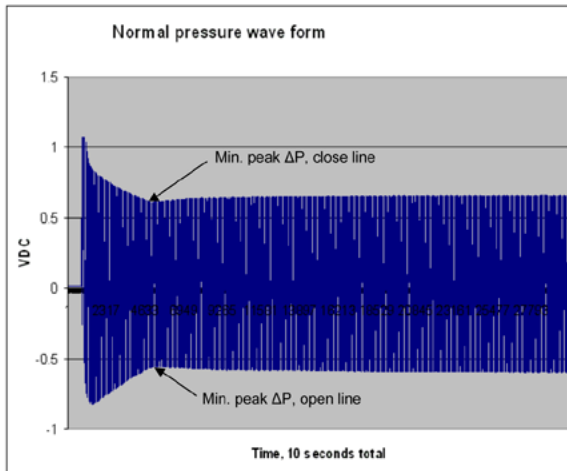
Figure 4-32 Normal Pressure Signal Sample

- 12.10.2 Immediately press "HOLD" to catch the pressure waveform. Release footswitch treadle.
- NOTE: The captured image must be similar in appearance to [Figure 4-32](#). If necessary to recapture the waveform, repeat steps [12.9](#) and step [12.10](#). Depressing the footswitch treadle when the Scopemeter sweep reaches the end of the Scopemeter display helps the waveform to begin at the beginning of the next sweep.**

- 12.11 Refer to waveform samples in [Figure 4-32](#) and [Figure 4-33](#), and determine if the waveform is normal or abnormal.
 - If the waveform is normal, continue to the next step.

12.12 Refer to [Figure 4-32](#) for Min. Peak locations. Use the horizontal cursor near the top of the screen to note the Min. Peak Close value.

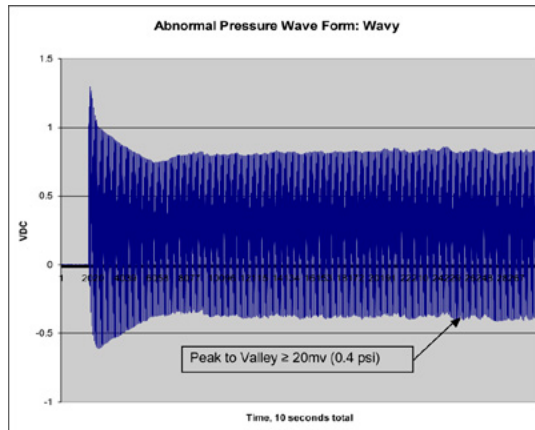
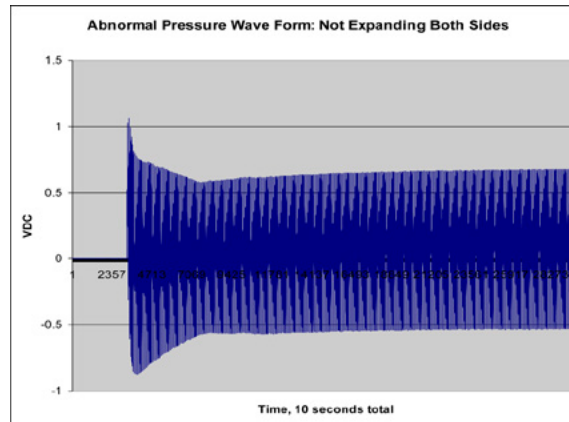
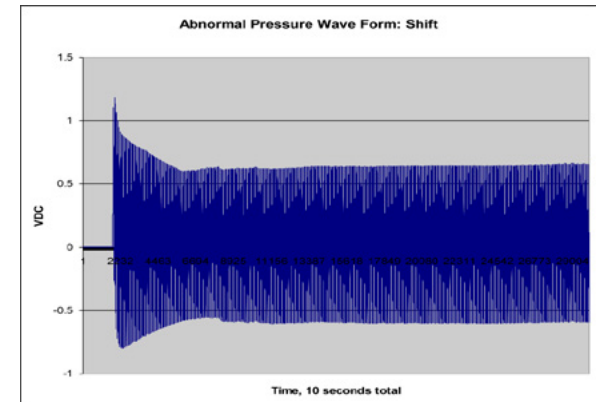
Figure 4-33 Abnormal Pressure Signal Samples

- If the waveform is abnormal, replace the Front Manifold/Fluidics PCB Assembly.

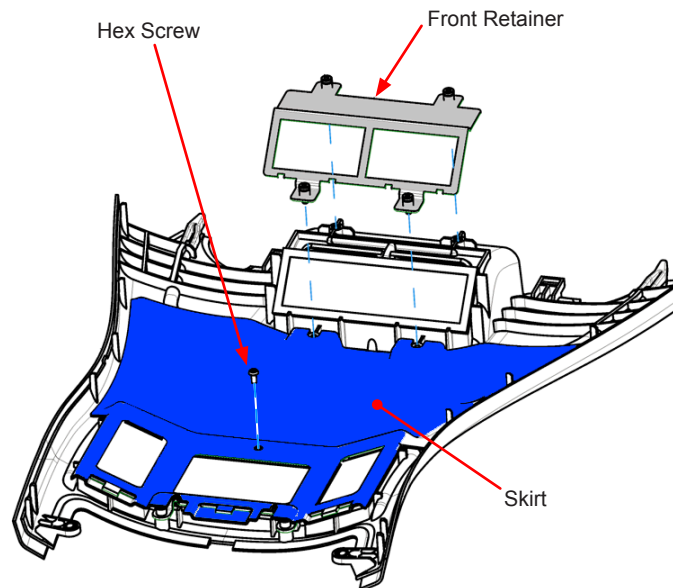
Figure 4-34 Lower Front Panel - Front Retainer and Skirt Removal

- 14.1 Remove the Lower Front Panel per Section Three of this manual.
- 14.2 Loosen four 3 mm captive screws securing the Front Retainer to the panel (see [Figure 4-34](#)). Remove Front Retainer and filter.

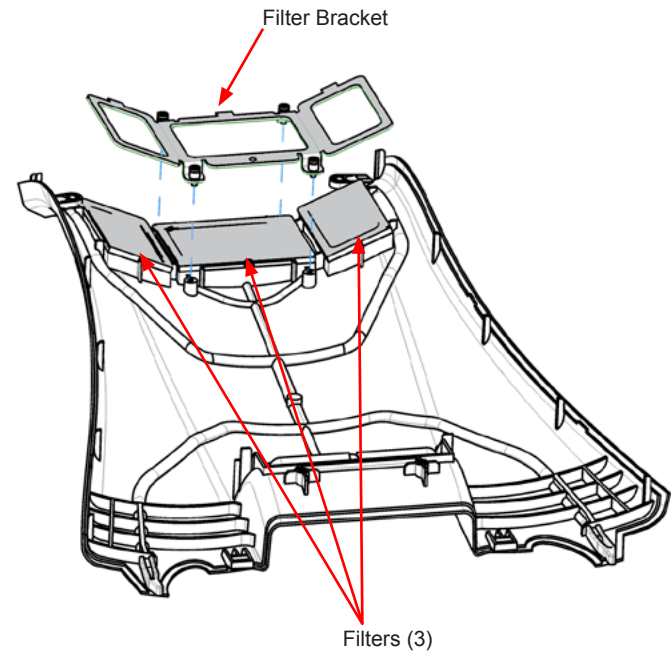
Figure 4-35 Lower Front Panel - Filter Bracket and Filter Removal

- 14.3 Remove 2.5 mm hex screw securing Skirt to Panel. Remove Skirt from Panel.
- 14.4 Loosen four 3 mm captive screws securing Filter Bracket to panel (see [Figure 4-35](#)). Remove Filter Bracket and three filters.

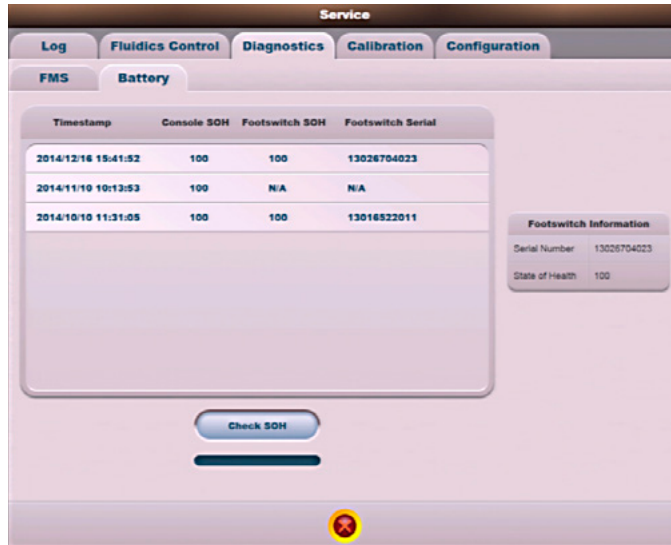
Figure 4-36 Battery State of Health Screen

- 15.1 Ensure wireless footswitch is paired to the console and placed on floor. Otherwise, the footswitch battery SOH will not be available.
- 15.2 Access Service screen.
- 15.3 Select Diagnostics tab then Battery tab (see [Figure 4-36](#)).

- 15.4 Select "Check SOH" and wait for its completion. This process should take around 50 minutes.
- 15.5 Replace battery if necessary.

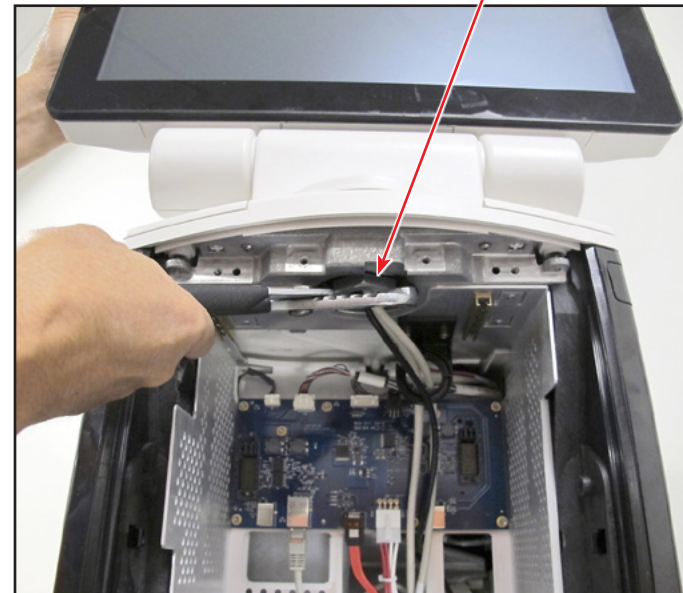
Loosen 1.5 inch Nut Using Channellock Plier

Figure 4-37 Display Rotation Adjustment

- 16.1 Remove the following panels per disassembly procedures in Section Three.
 - Front Vent Panel
 - Upper Front Panel
 - Lower Front Panel
- 16.2 Remove the following components:
 - Ultrasonics (U/S) Controller Assembly
 - Fluidics Module and Fluidics Controller Assembly.
- 16.3 With one hand holding the Display Assembly, loosen a 1.5 inch nut on the Display Arm Base Mount Assembly using channellock plier as shown in [Figure 4-37](#).

NOTE: Do not loosen the nut more than half a turn. Loosen more than half a turn could cause tension to roller bearing on Display Arm Base Rotating Hub to be too loose.

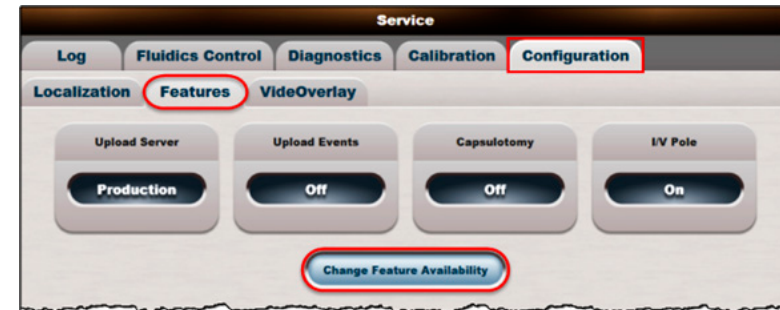
Figure 4-39 Service Mode\Configuration\Features - Change Feature Availability

- 17.2.1 Navigate to Service mode.
- 17.2.2 Select Configuration tab then Features sub-tab.
- 17.2.3 Select Change Feature Availability to enable uploading of events (see [Figure 4-39](#)).

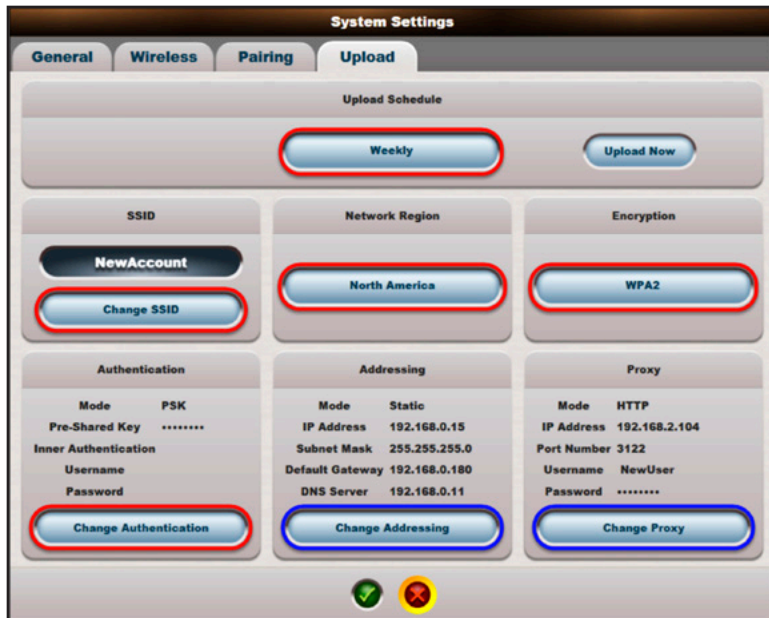
Figure 4-41 System Settings\Upload Tab

17.3.1 Navigate to System Settings and select the Upload tab (see [Figure 4-41](#)).

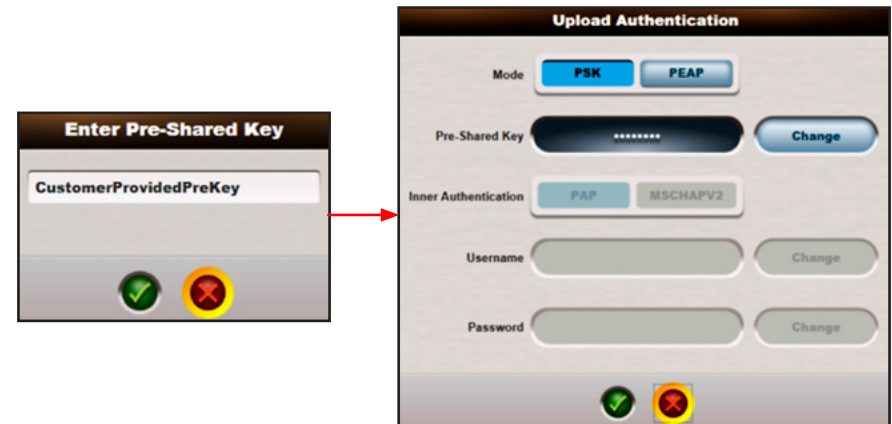
Figure 4-46 Authentication Screens

17.3.6.1 Press Change Authentication button, then touch the Change button and enter the Pre-Shared Key passcode provided by the account (see [Figure 4-46](#)).

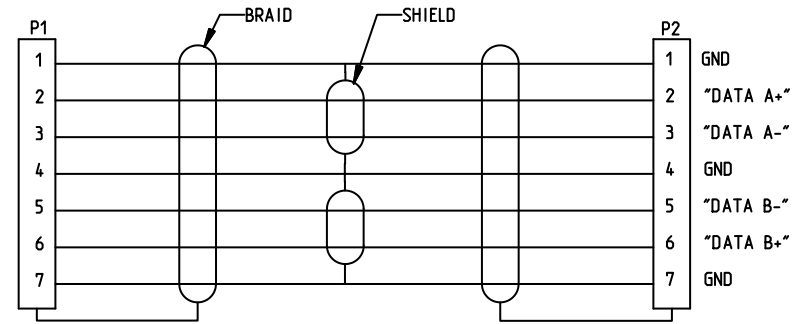
023-163 A

W102 - EXTERNAL SATA 24"

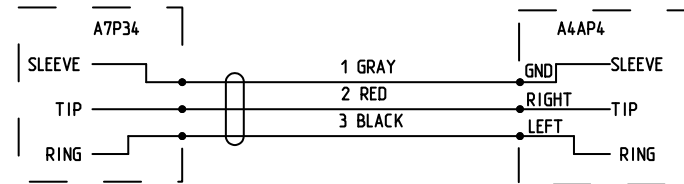
215-1105-001 A

W105 - AUDIO EXT

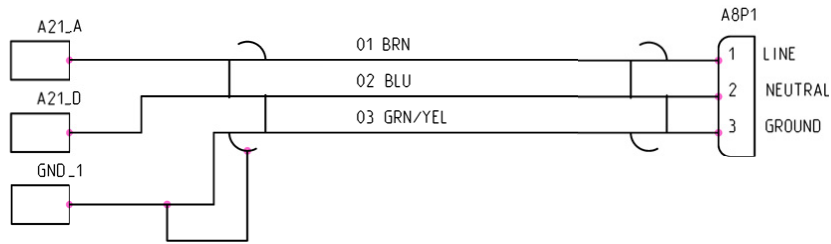
215-3002-001 B

W111 - POWER ENTRY

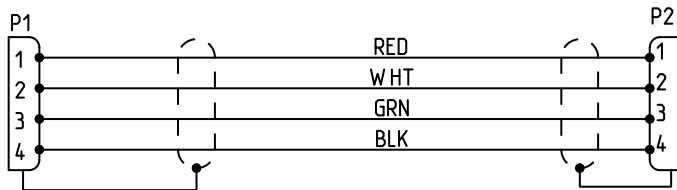
023-167 A

W112 - USB 2.0, A PLUG 1M

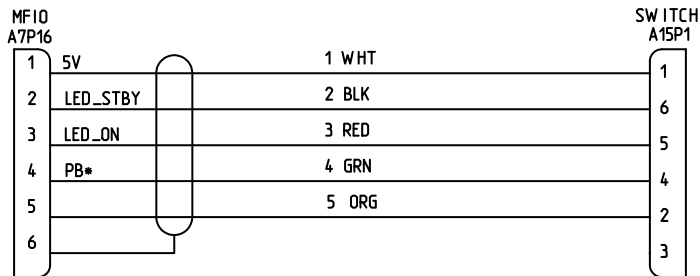
215-1113-001 A

W113 - STANDBY SWITCH

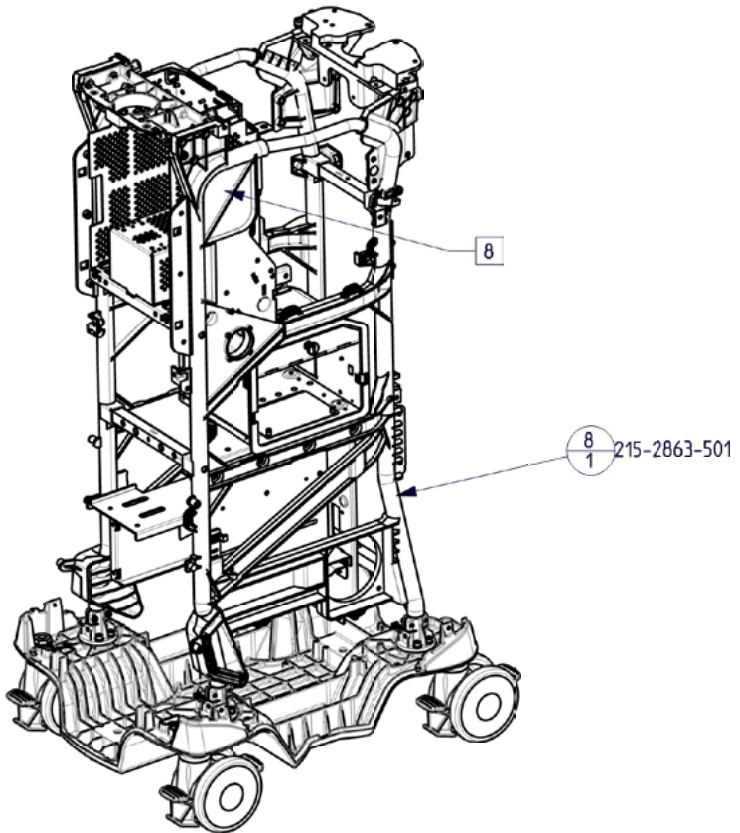
STEP 1

1. RECORD BASE ASSY 215-2863-501 REVISION ONTO DHR DATA SHEET.
2. REMOVE TAG FROM BASE ASSY 215-2863-501.
3. WITH A SILVER MARKER, MARK CONSOLE PART NUMBER, REVISION LETTER, AND SERIAL NUMBER
ON BASE ASSY 215-2863-501 IN APPROXIMATE LOCATION IDENTIFIED BY 8 ABOVE.

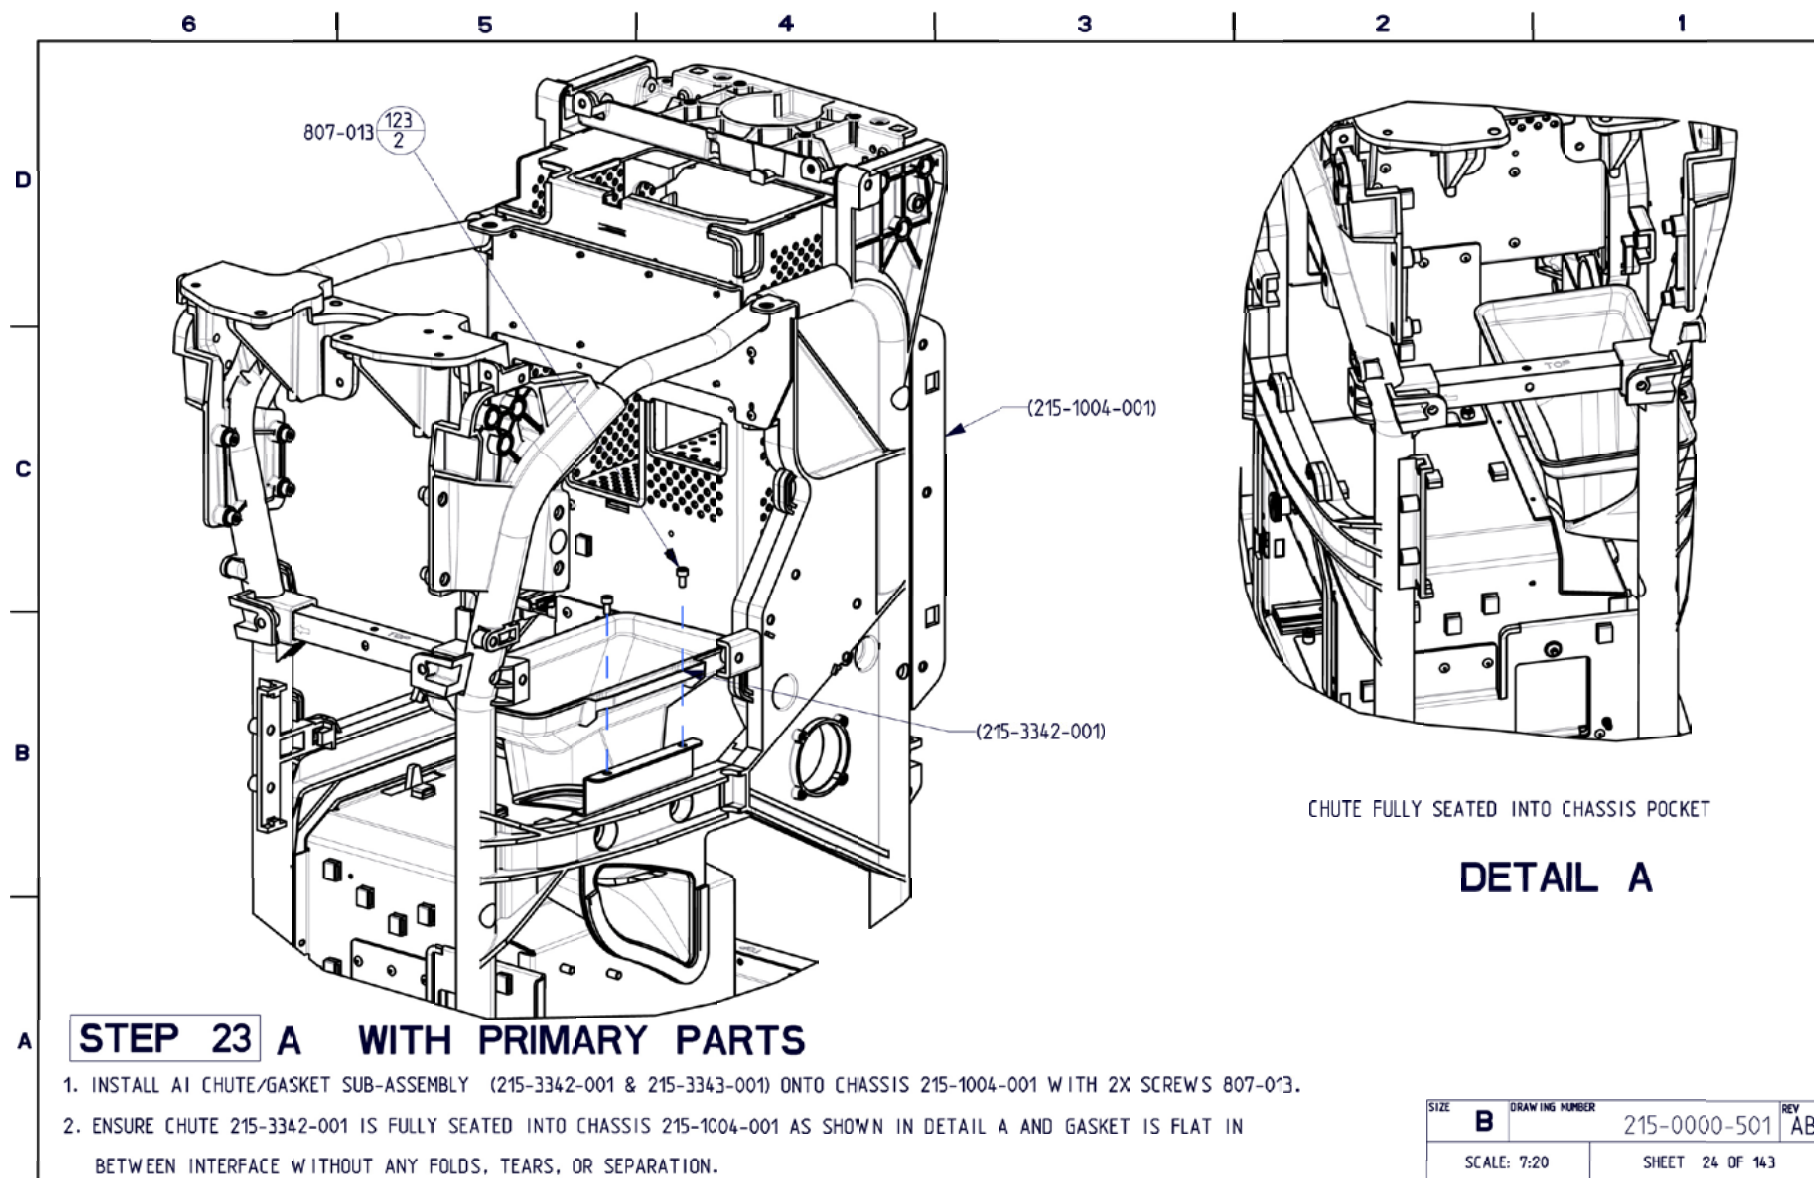
SIZE	B	DRAWING NUMBER	215-0000-501	REV	AB
SCALE: 1:2		SHEET 25 OF 143

1. TO ENSURE THE AI CHUTE (215-3342-001) HAS BEEN ASSEMBLED CORRECTLY, LIGHTLY PULL UP ON AI CHUTE IN THE LOCATION SHOWN BY ARROW ABOVE. THE AI CHUTE SHOULD NOT PULL AWAY FROM THE FRAME INTERFACE, IT SHOULD STAY LOCKED IN PLACE WITH THE FRAME.
2. IF THE AI CHUTE DOES COME LOOSE, THEN DISASSEMBLE SCREWS FROM PREVIOUS STEP AND ATTEMPT THE ASSEMBLY AGAIN ENSURING THE CHUTE INSTALLS FULLY INTO FRAME INTERFACE.
